# Trip to Sunshine Coast Queensland, September 2004 Visit to Schools

## Report No 2002-059-B No 7

**Project Name** Case Based Reasoning in Construction and Infrastructure Projects

**Date:** January 2005

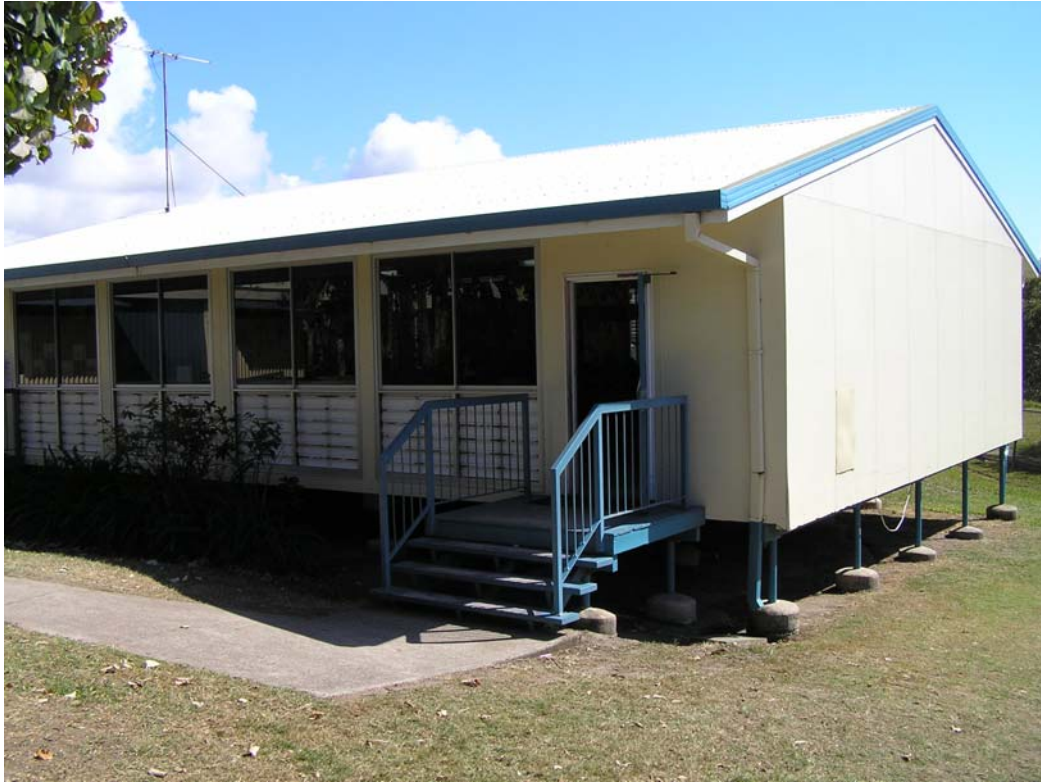
Figure 5 Modular 1 class room at Currimundi State School

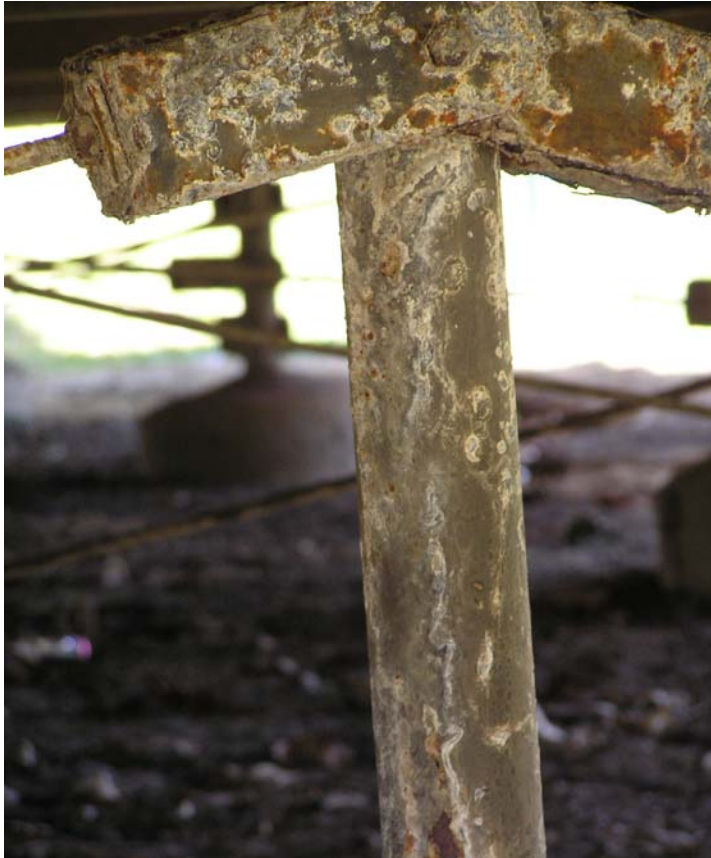
Figure 9 Stump support of Modular 1.

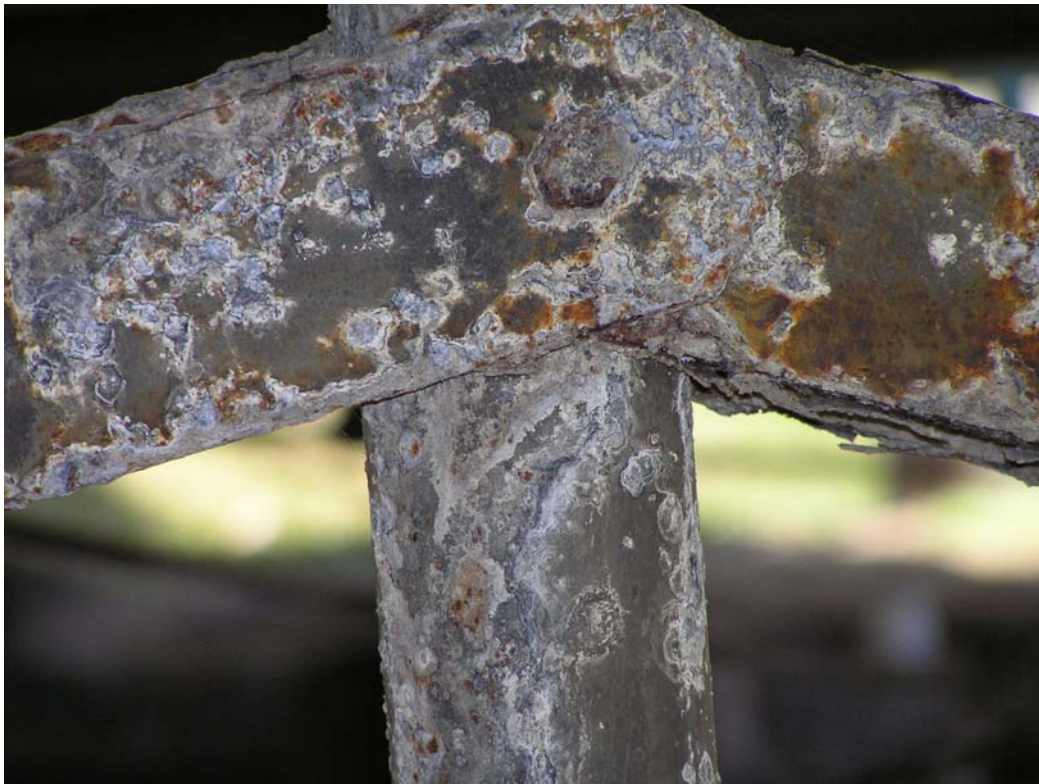
Figure 10 Close up of stump of Modular 1.

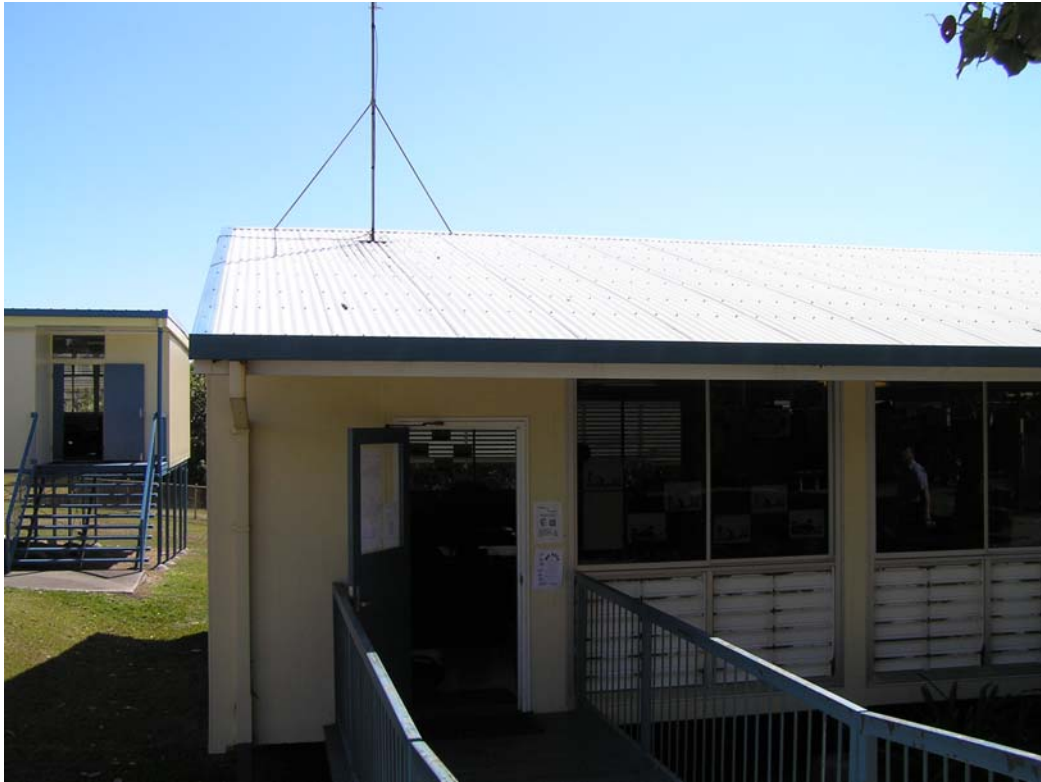
Figure 11 West end of roof of Modular 1.

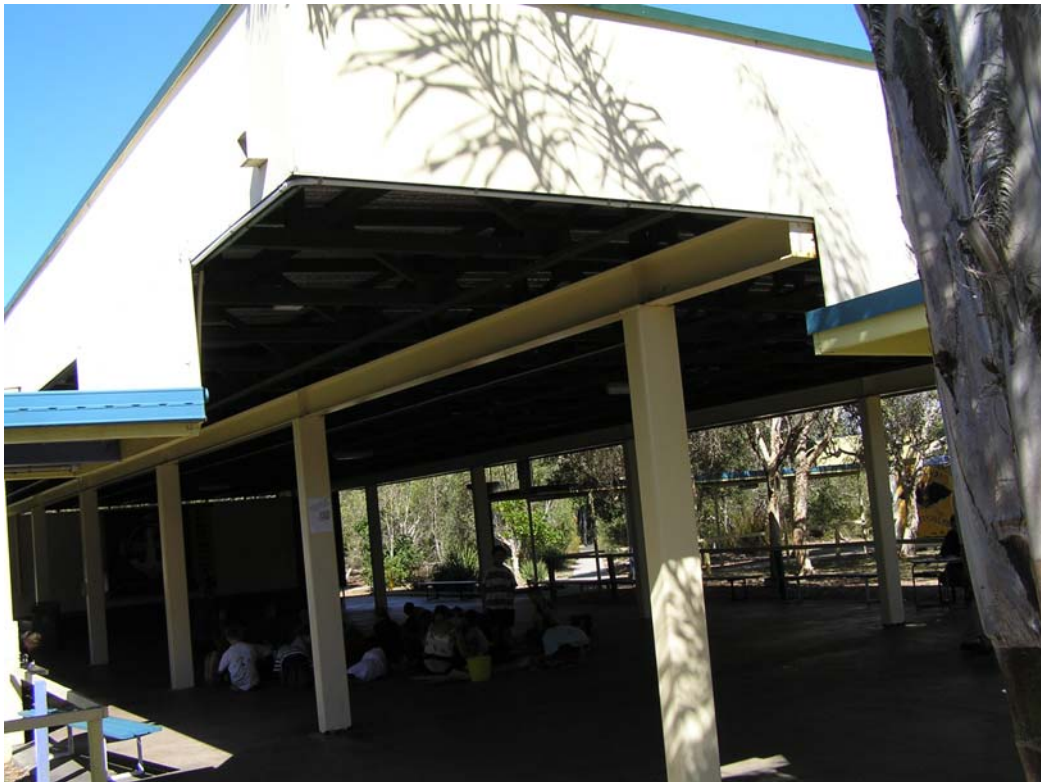
Figure 14 Covered games area.

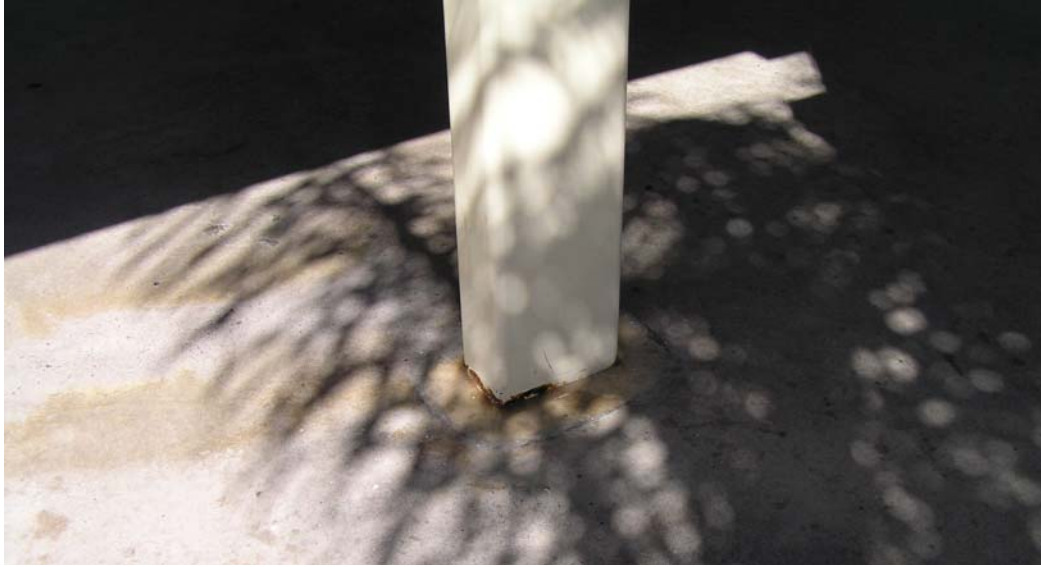
Figure 15 Footing of steel support showing red corrosion product.

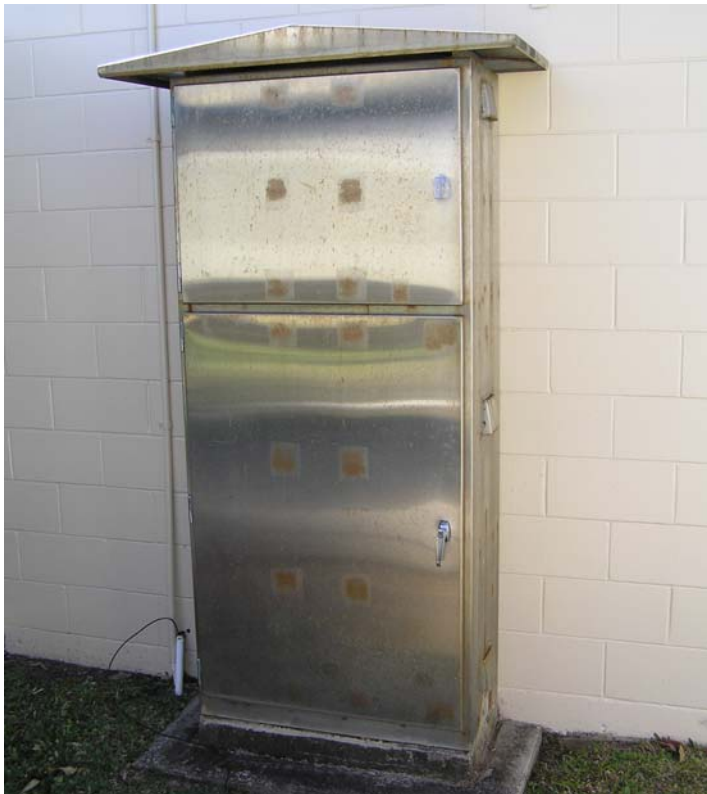
Figure 23 Stainless steel equipment box showing signs of rust where signs were affixed with tape.

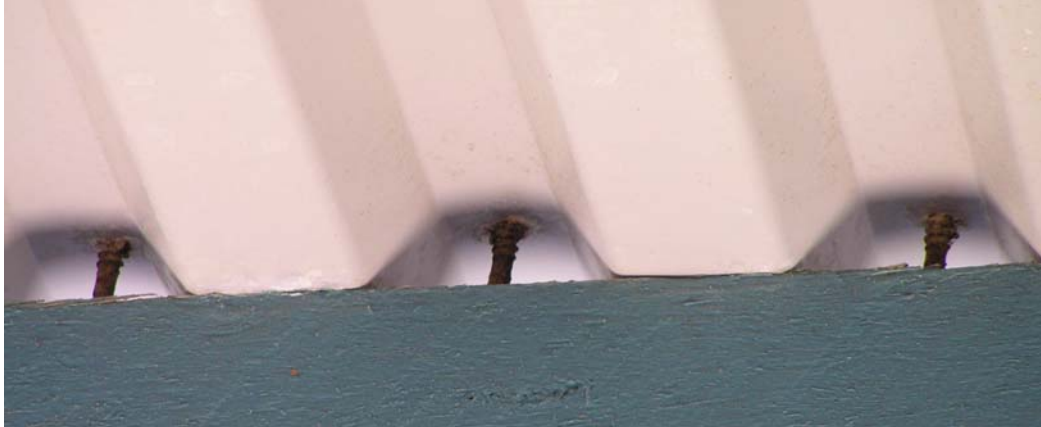
Figure 27 Covered walkway, fastener shanks are red rust and undercutting seen on Colorbond sheeting.

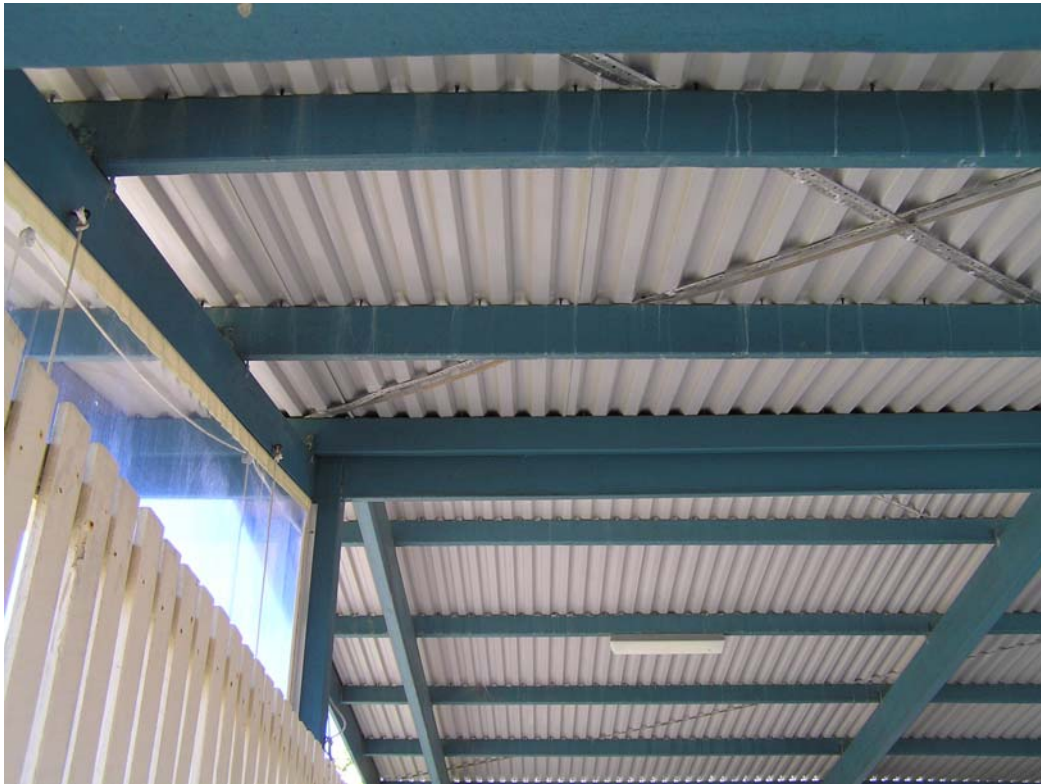
The following figures show an attempt at building with more corrosion resistant components but actually causing additional problems. Stainless steel strapping was used in the construction of the Covered set down but it is in contact with the Colorbond roof sheeting. The strap that is not in contact is corroding and the strap in contact with the Colorbond is causing the Colorbond to corrode. The Colorbond is showing significant red rust and will in the near future if it hasn't already, corrode through. This could have been avoided by making sure the strapping did not touch the Colorbond sheeting.

Figure 28 Covered set down structure.

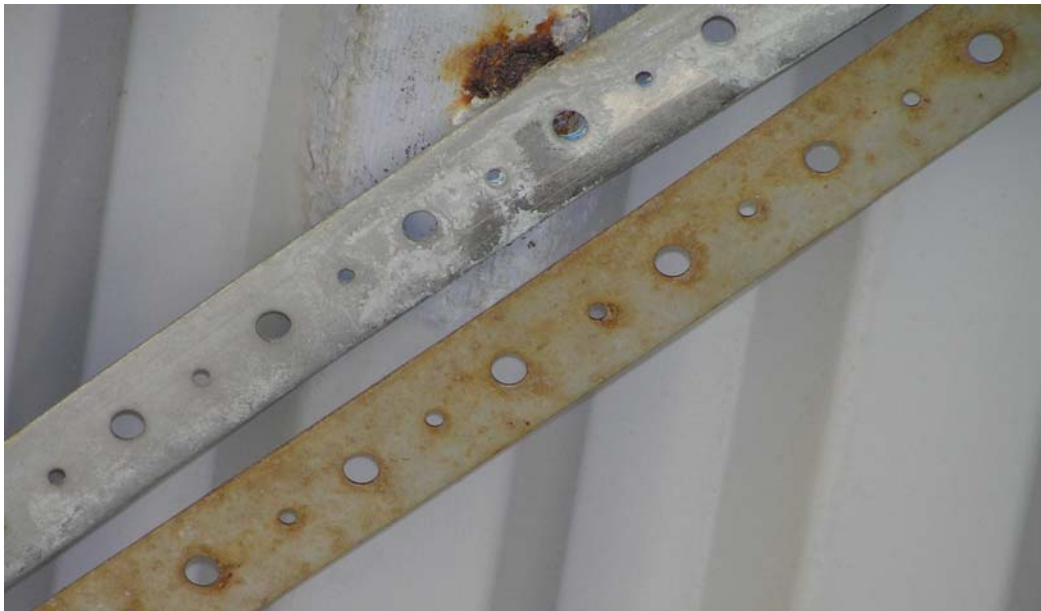
Figure 31 Close up showing red rust of stainless steel strapping not in contact with roof sheeting and red rust on roof sheeting where stainless steel strapping is in contact.

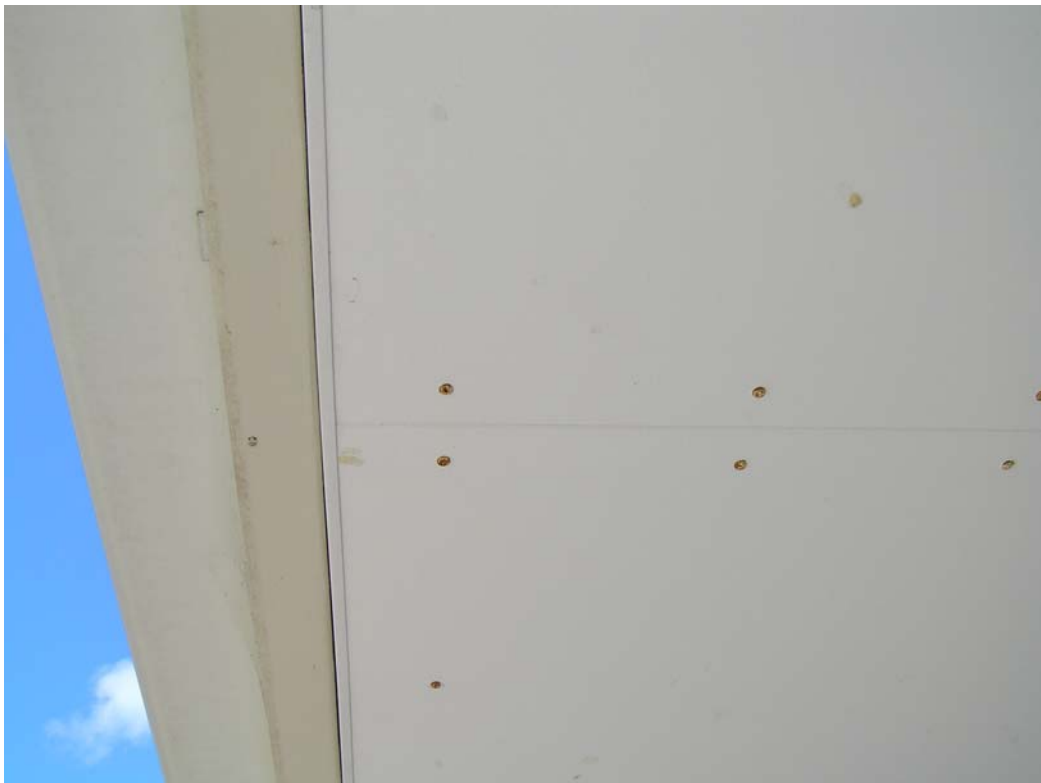
Figure 37 Fasteners in sheeting on porch of Administration Block.

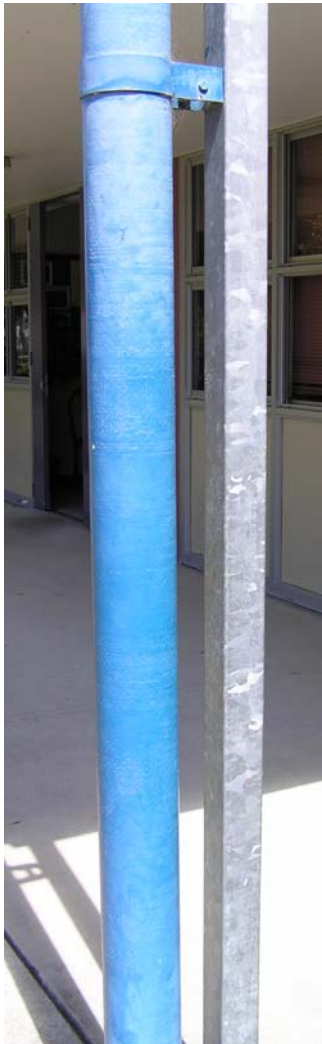
Figure 39 Galvanised post on Administration Block and close up showing signs of white corrosion product.

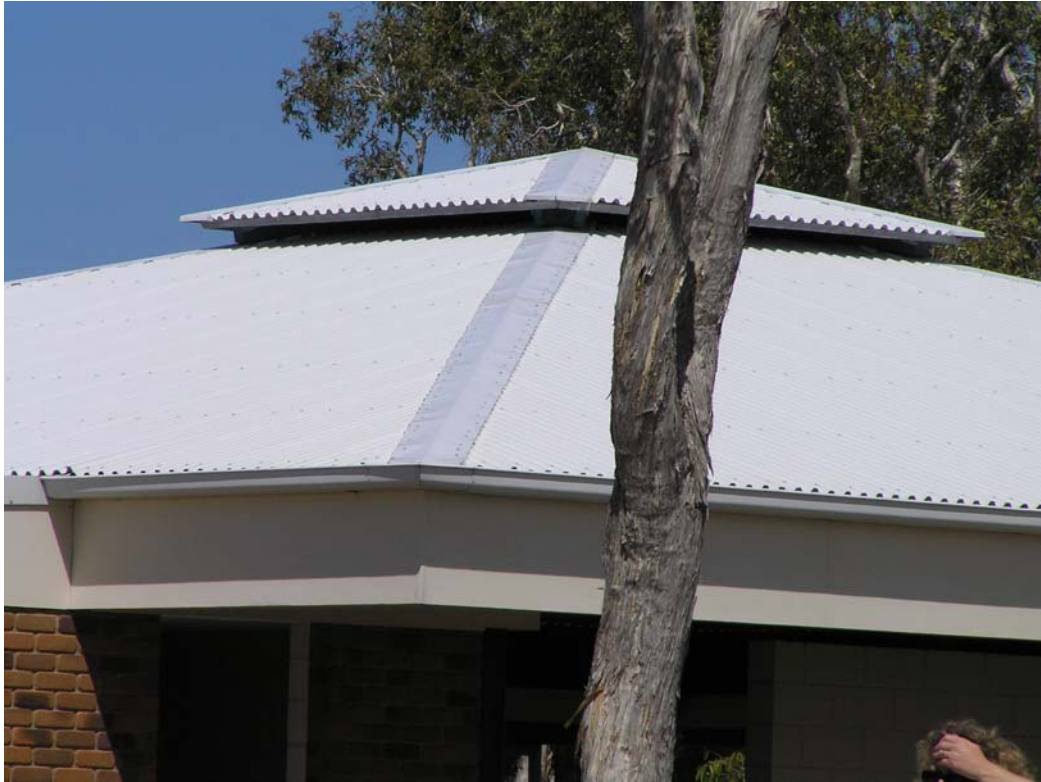
Figure 42 Covered court.

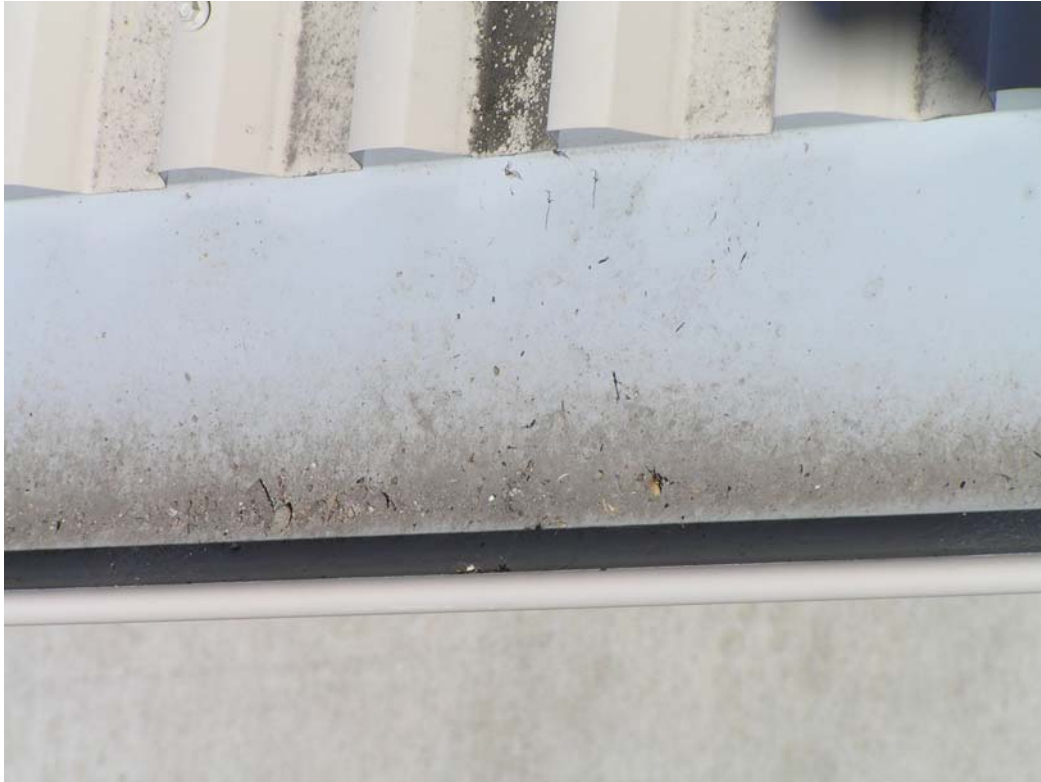
Figure 49 Inside gutter of walkway from block E.

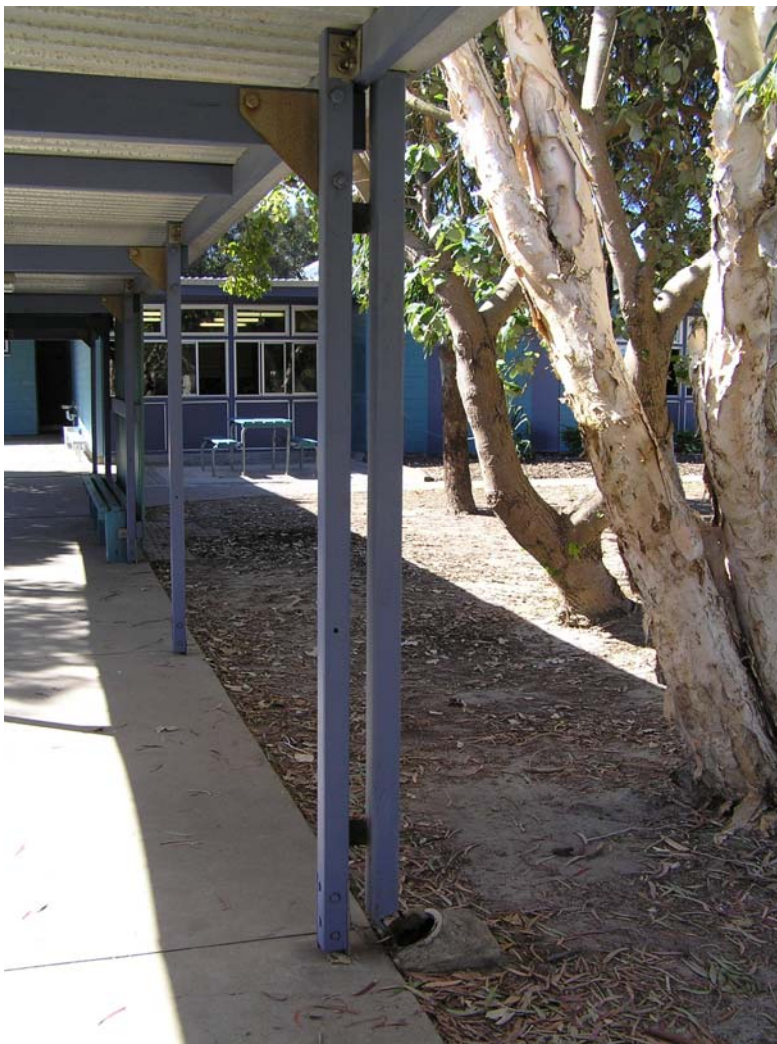
On some covered walkways square section steel was used as downpipes. It is assumed the steel was used as standard downpipes would be destroyed by the students. It can be seen in the following figures that the painted steel is corroding from the inside out.

Figure 64 Covered walkway showing timber support and steel down pipe.

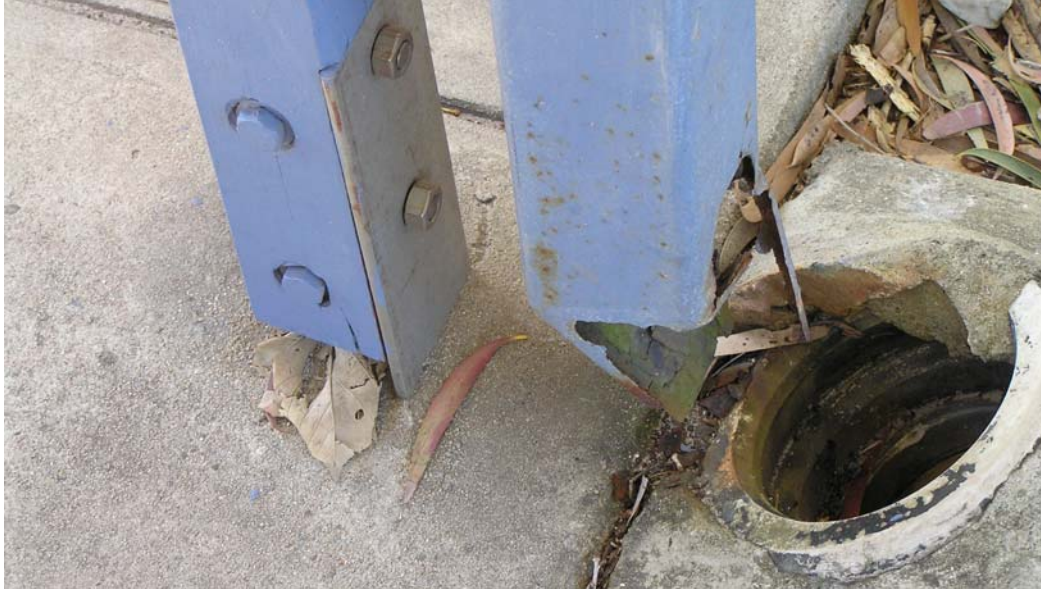
Figure 65 Bottom of square section, steel completely rusted away.

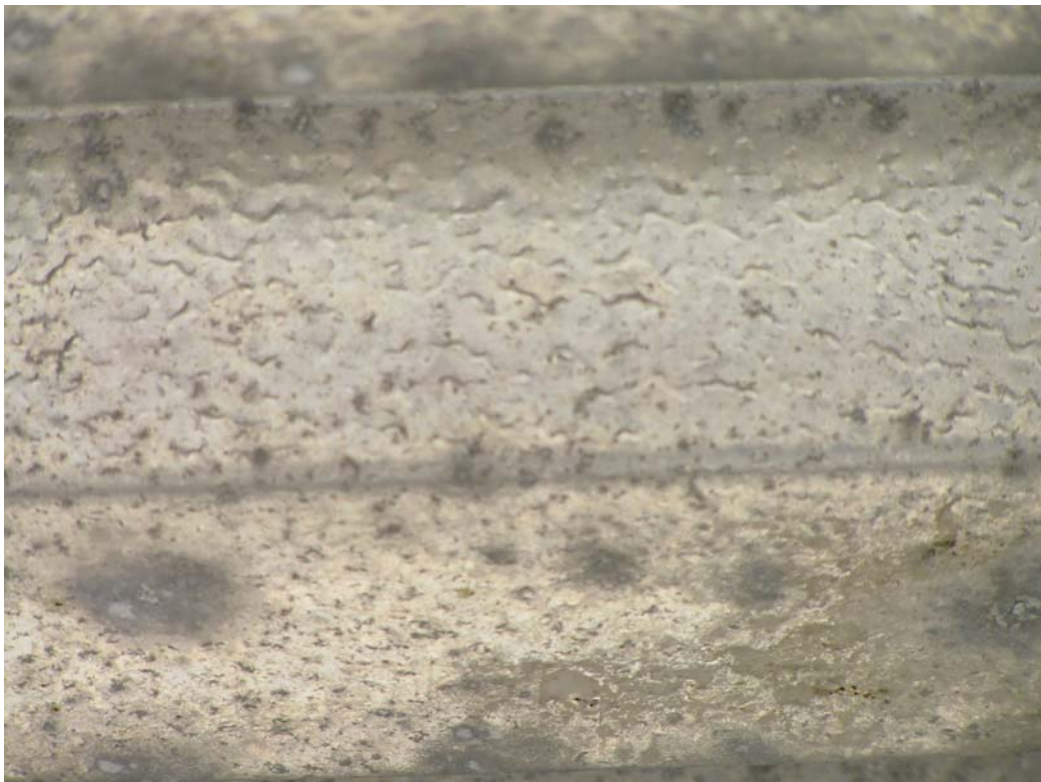
The aluminium sheeting used on the walkways looked ok on the exposed outer surface but underneath there was significant corrosion. It looked like galvanised fasteners were used to fasten the sheeting and these were corroded on the heads, some to 100% red rust. The shanks of all the fasteners were heavily corroded.

Figure 69 Close up of underside of aluminium roof sheeting of covered walkway.

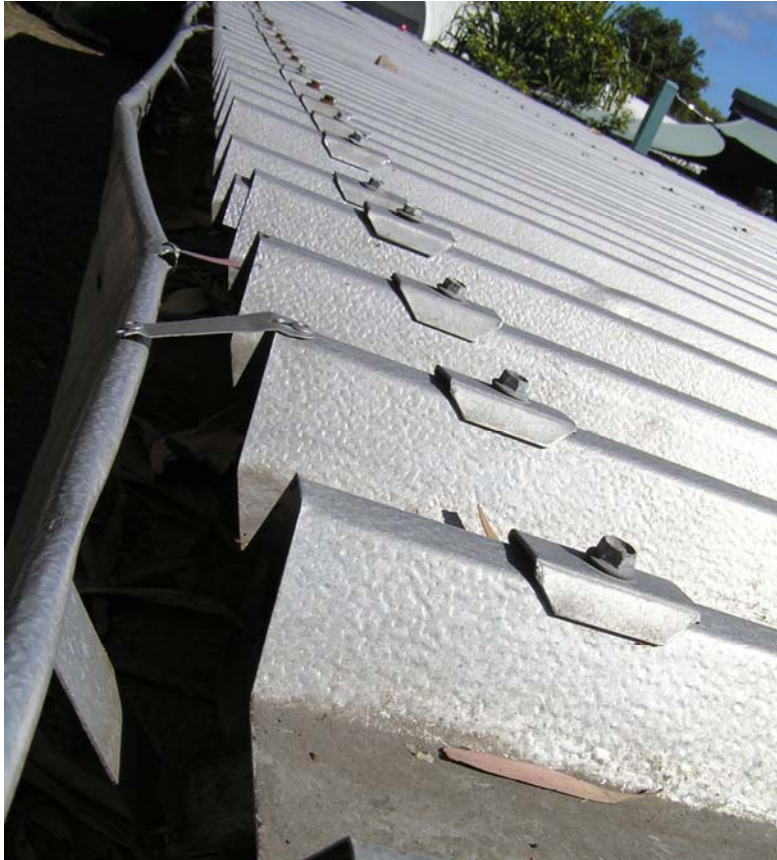
Figure 74 Exposed surface of aluminium walkway in good condition.

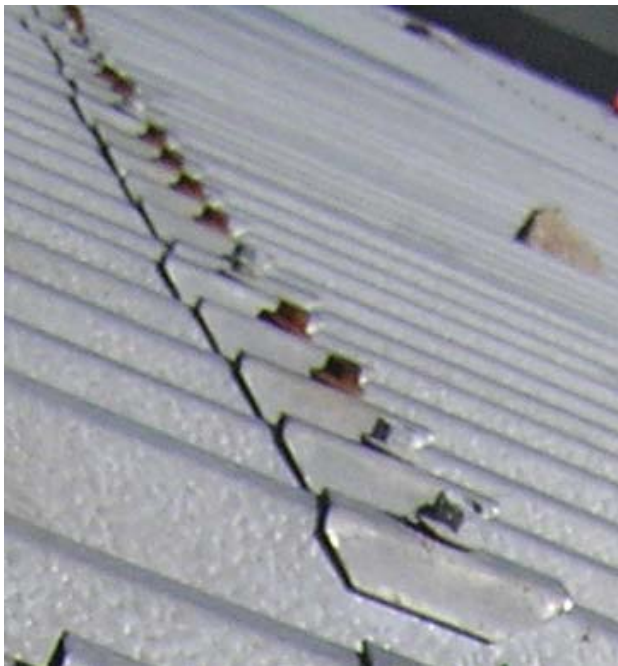
Figure 75 Close up of above figure showing fasteners with red rust.

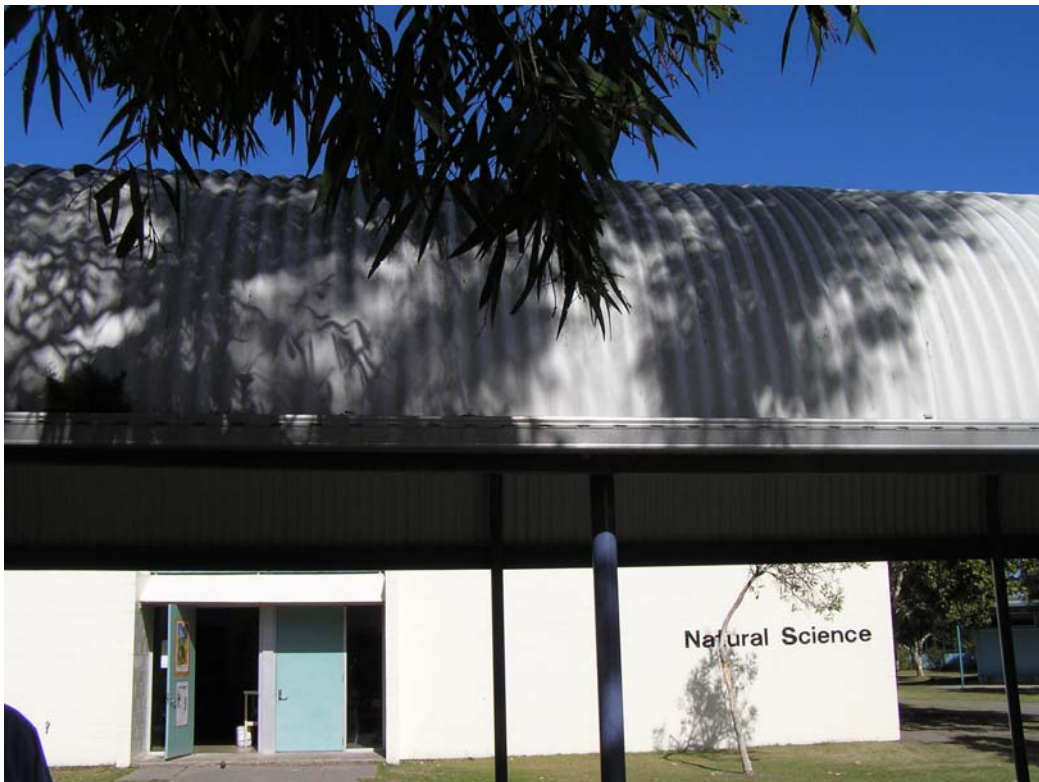
All the aluminium gutters showed corrosion on the underneath side, even on the colorbond walkways. As with the other schools where joins were made in the gutters significant deterioration had occurred.

Figure 79 Colorbond walkways with aluminium gutters.

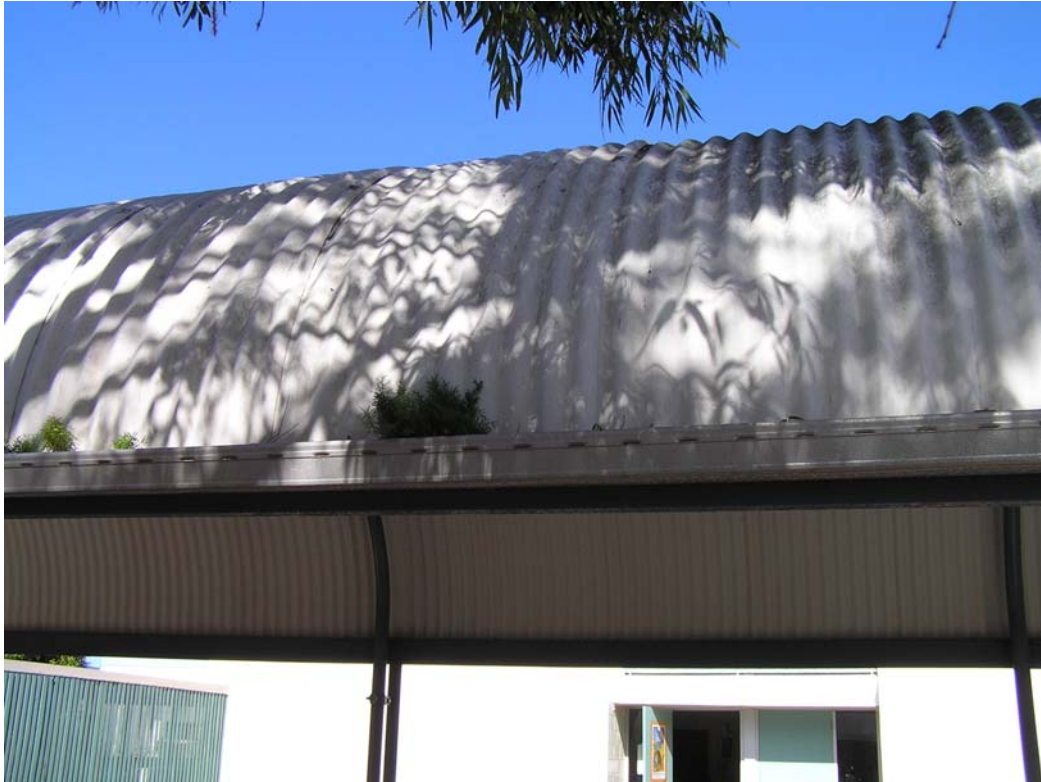
Figure 80 Colorbond walkways with aluminium gutters which are full of leaves and dirt.

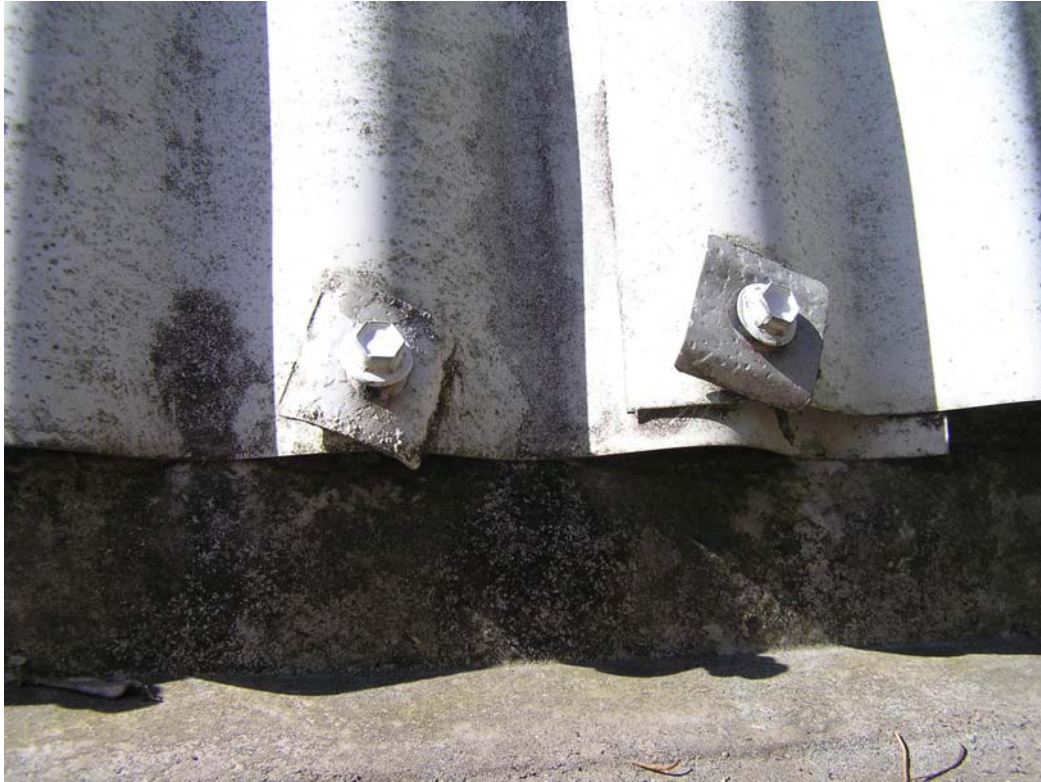
Figure 94 Colorbond sheeting and aluminium gutter showing significant growths.

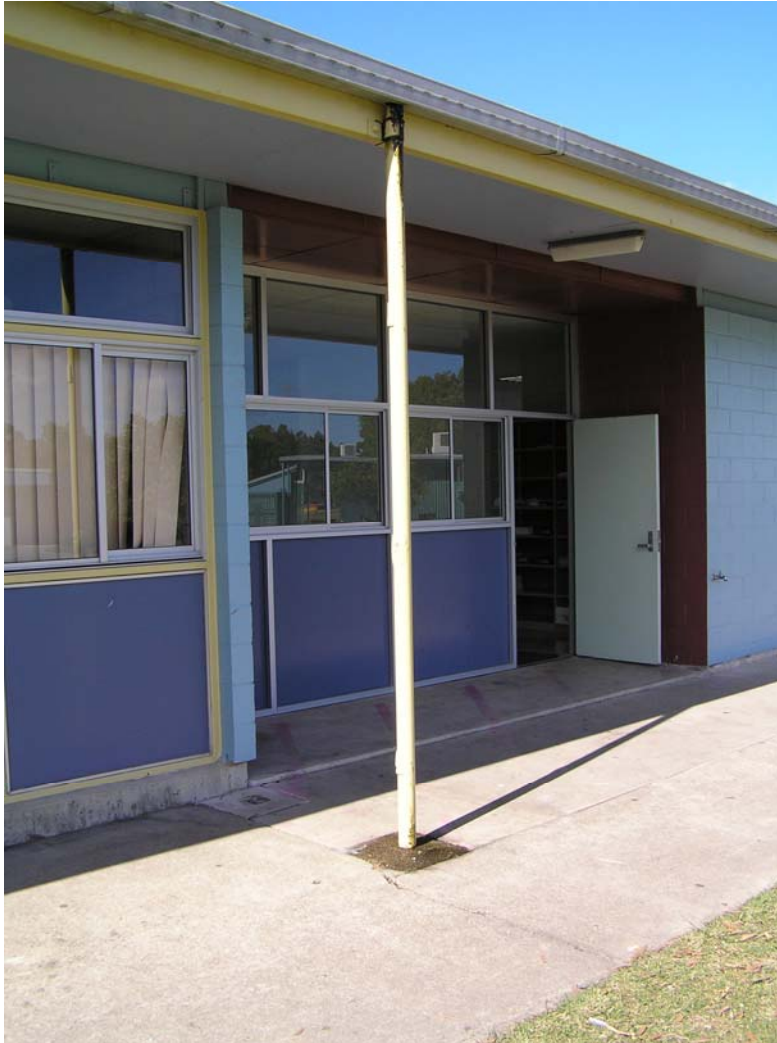
Another problem seen at this school is the use of structural downpipes. This is where as seen in the following figures the downpipe forms part of the structure holding up the eaves of the building. There is a steel U section around the edge of the eave with a piece of timber inside it. The U section is bolted to the downpipe. What seems to be happening is that the gutters, which are a fairly small diameter, block up. The water then overflows at the downpipe onto the U section and corrodes the U section and the timber is wet helping the corrosion. It was said that it costs \$80,000 to replace the steel U sections on one building.

Figure 97 Structural downpipes.
